CONFIRMATORY SAMPLING WORK PLAN AREA OF CONCERN 726 (AOC 726) ZONE H  
CNC CHARLESTON SC  
3/1/2006  
CH2M HILL

# CONFIRMATORY SAMPLING WORK PLAN

## AOC 726. Zone H

***Charleston Naval Complex  
North Charleston, South Carolina***

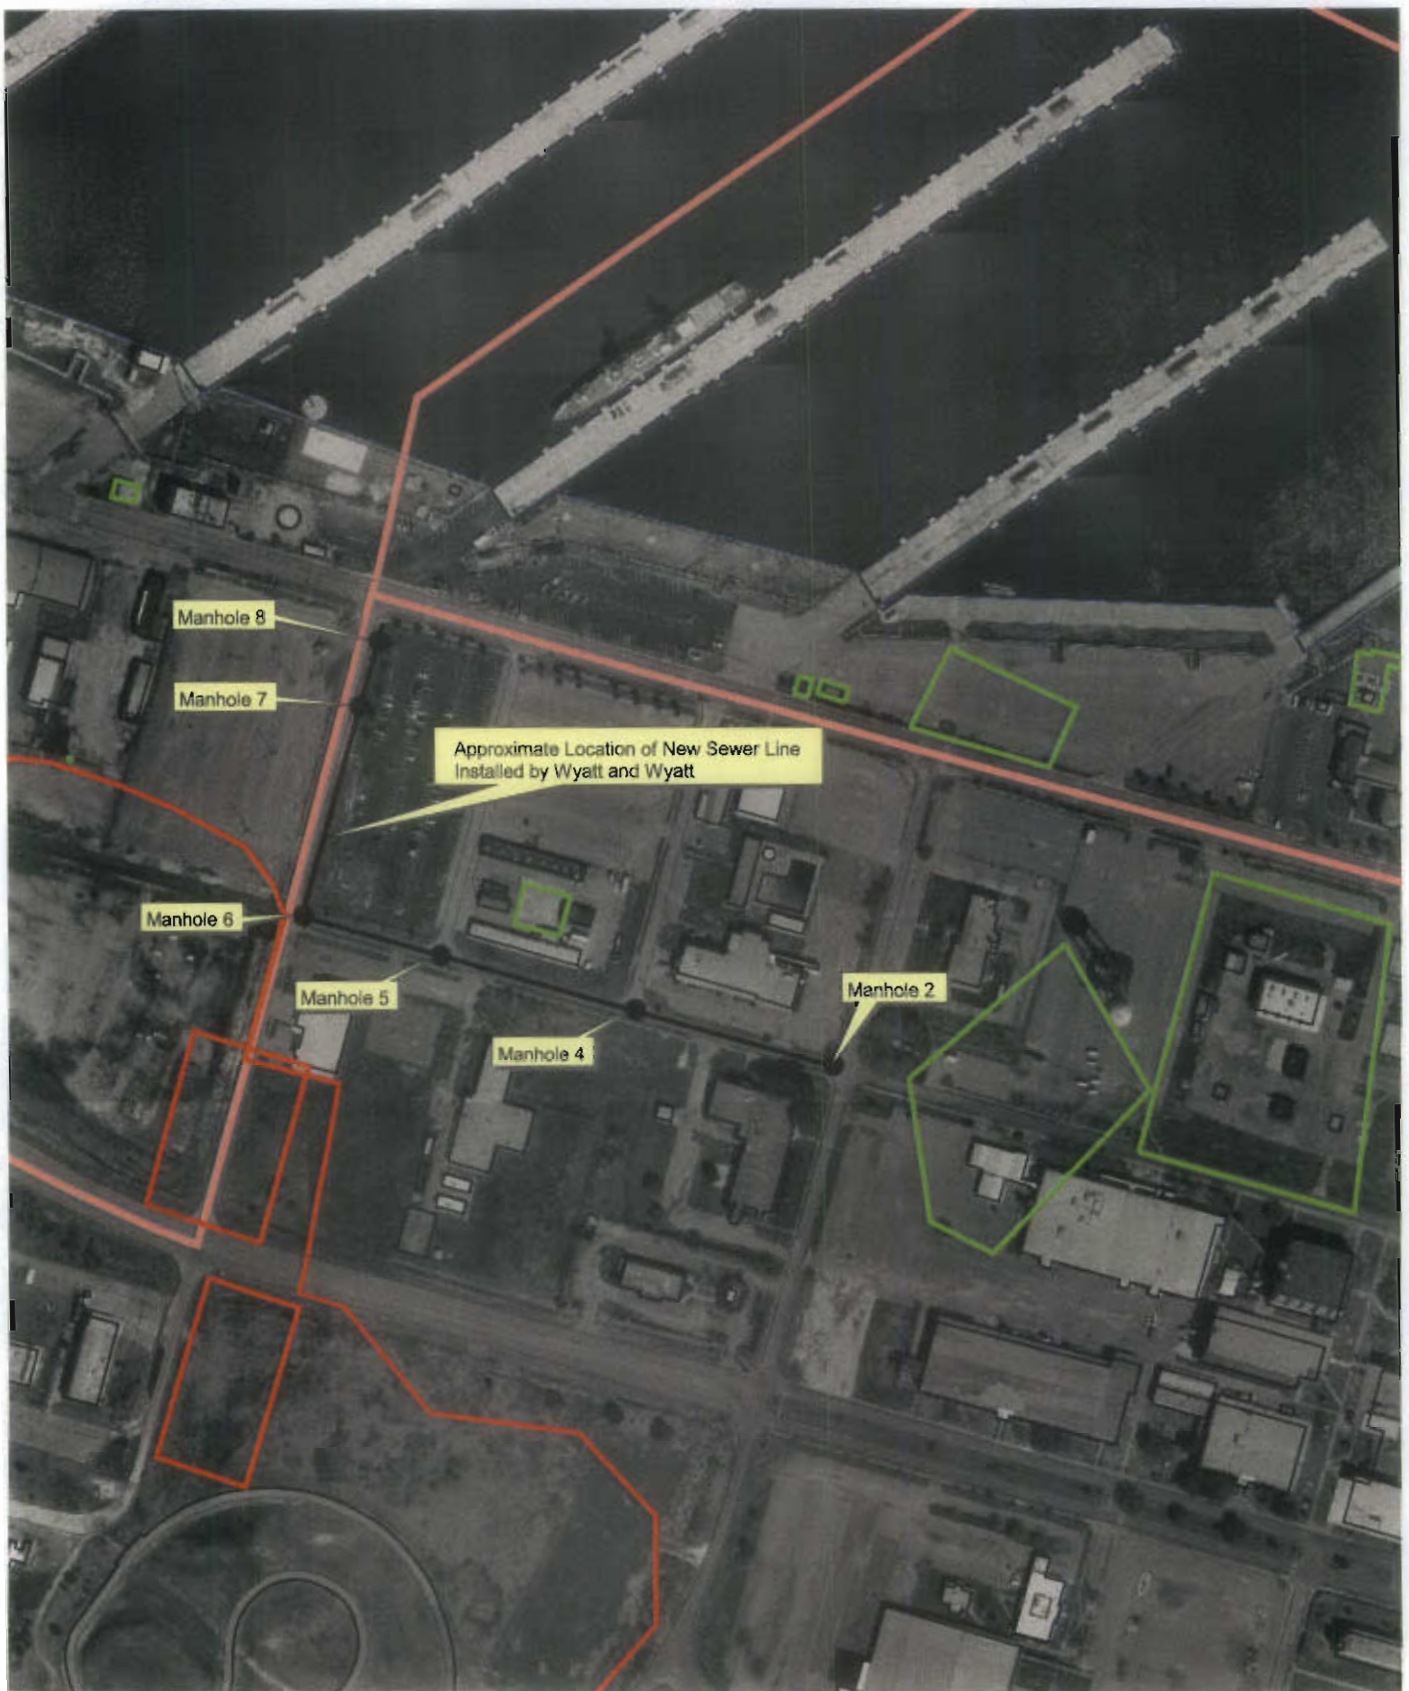
**FIGURE 2-4**  
PSC Soil Sampling Locations  
Based on *Industrial Hygiene Sampling Report* (PSC, 2003)  
AOC 726, Zone H, Charleston Naval Complex

The PID readings from the four sampling areas are summarized in **Table 2-1**. **Figure 2-1** shows the general locations at which these samples were collected, based on the descriptions provided in the PSC report.

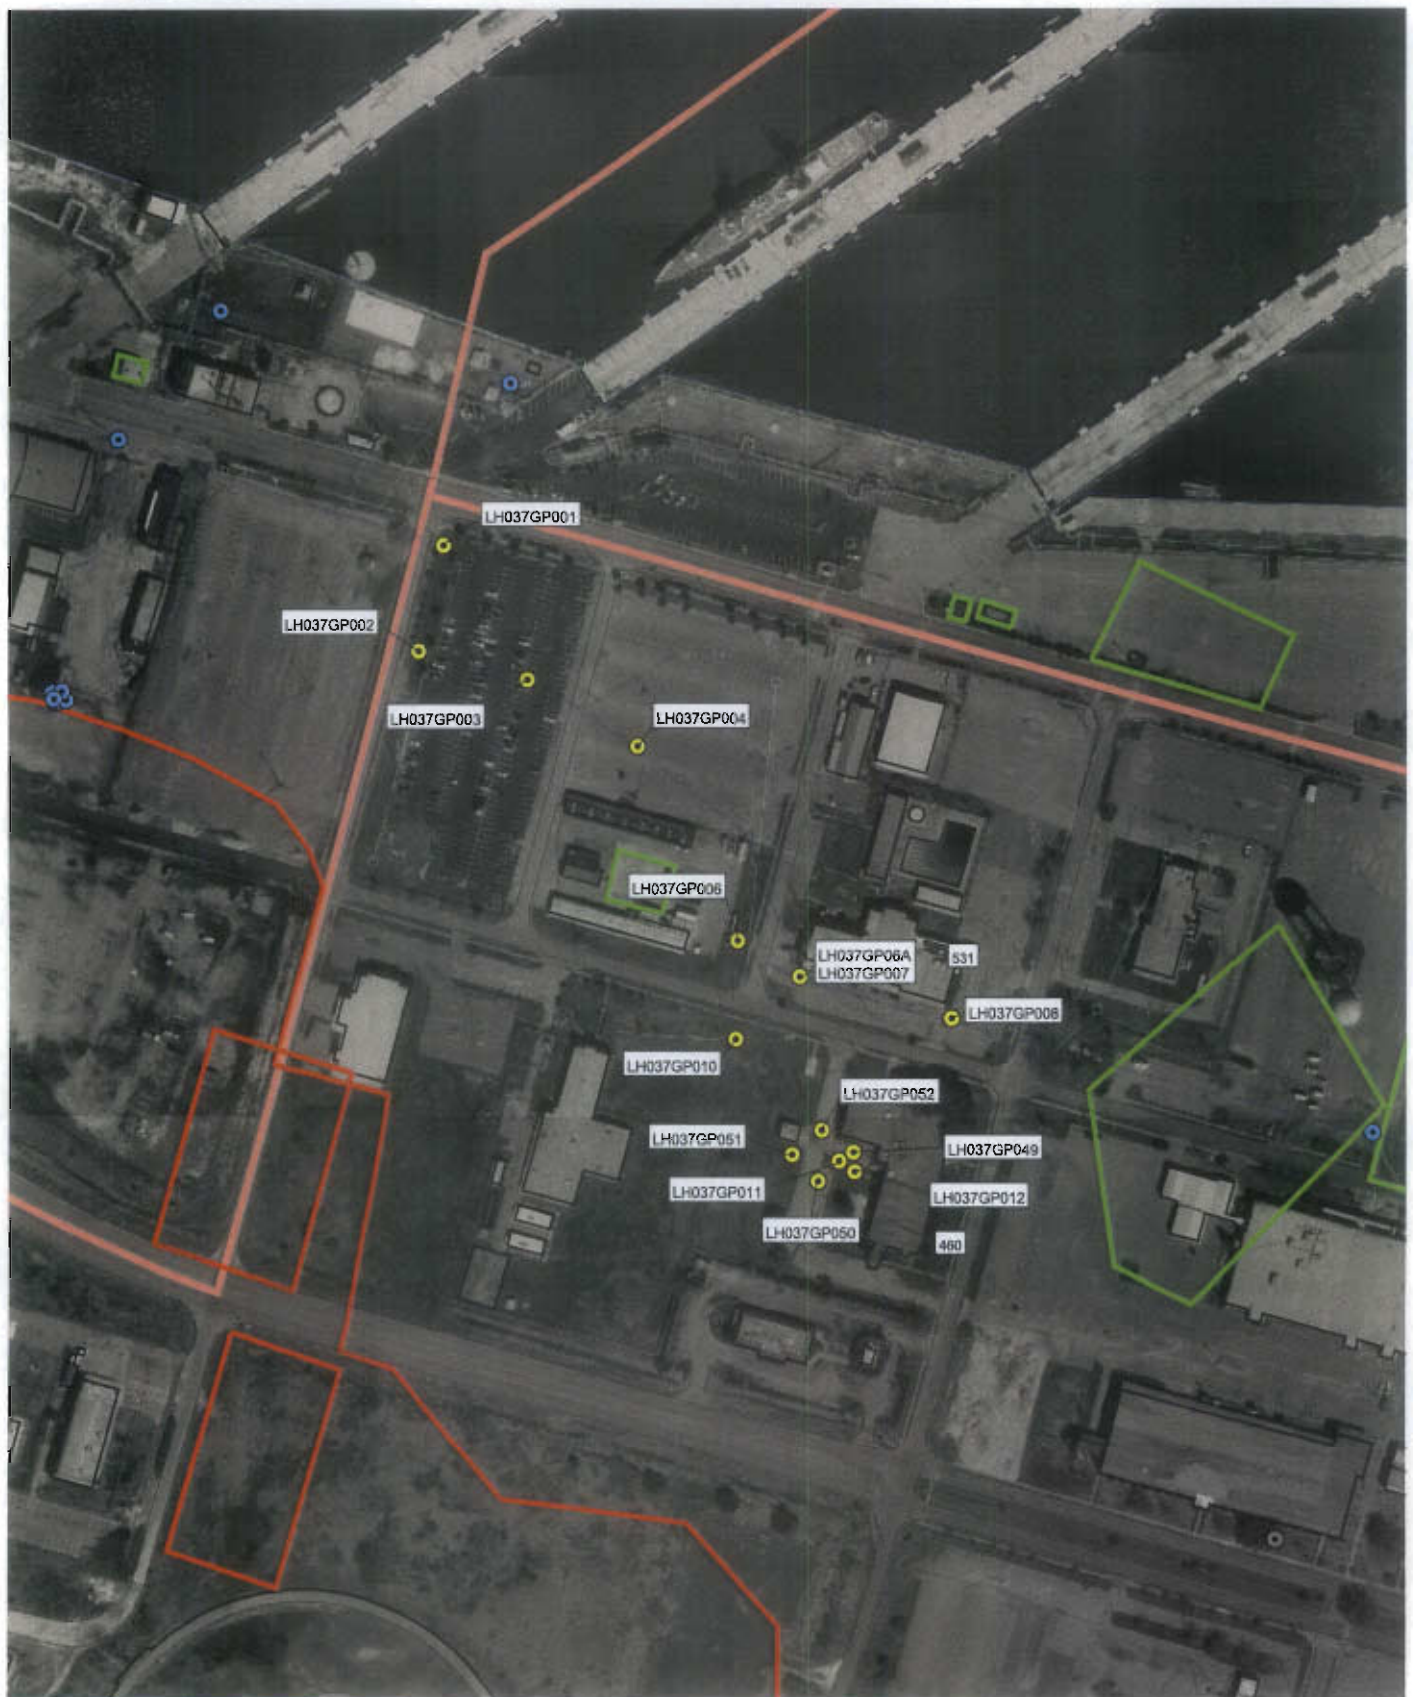
**FIGURE 3-1**  
DTP Groundwater Sampling Locations Near AOC 726  
AOC 726, Zone H, Charleston Naval Complex

- Groundwater Probe
- SEWER-LINE/MANHOLE-NS
- SEWER-LINE/MANHOLE
- SEWER-FLOW-ARROW

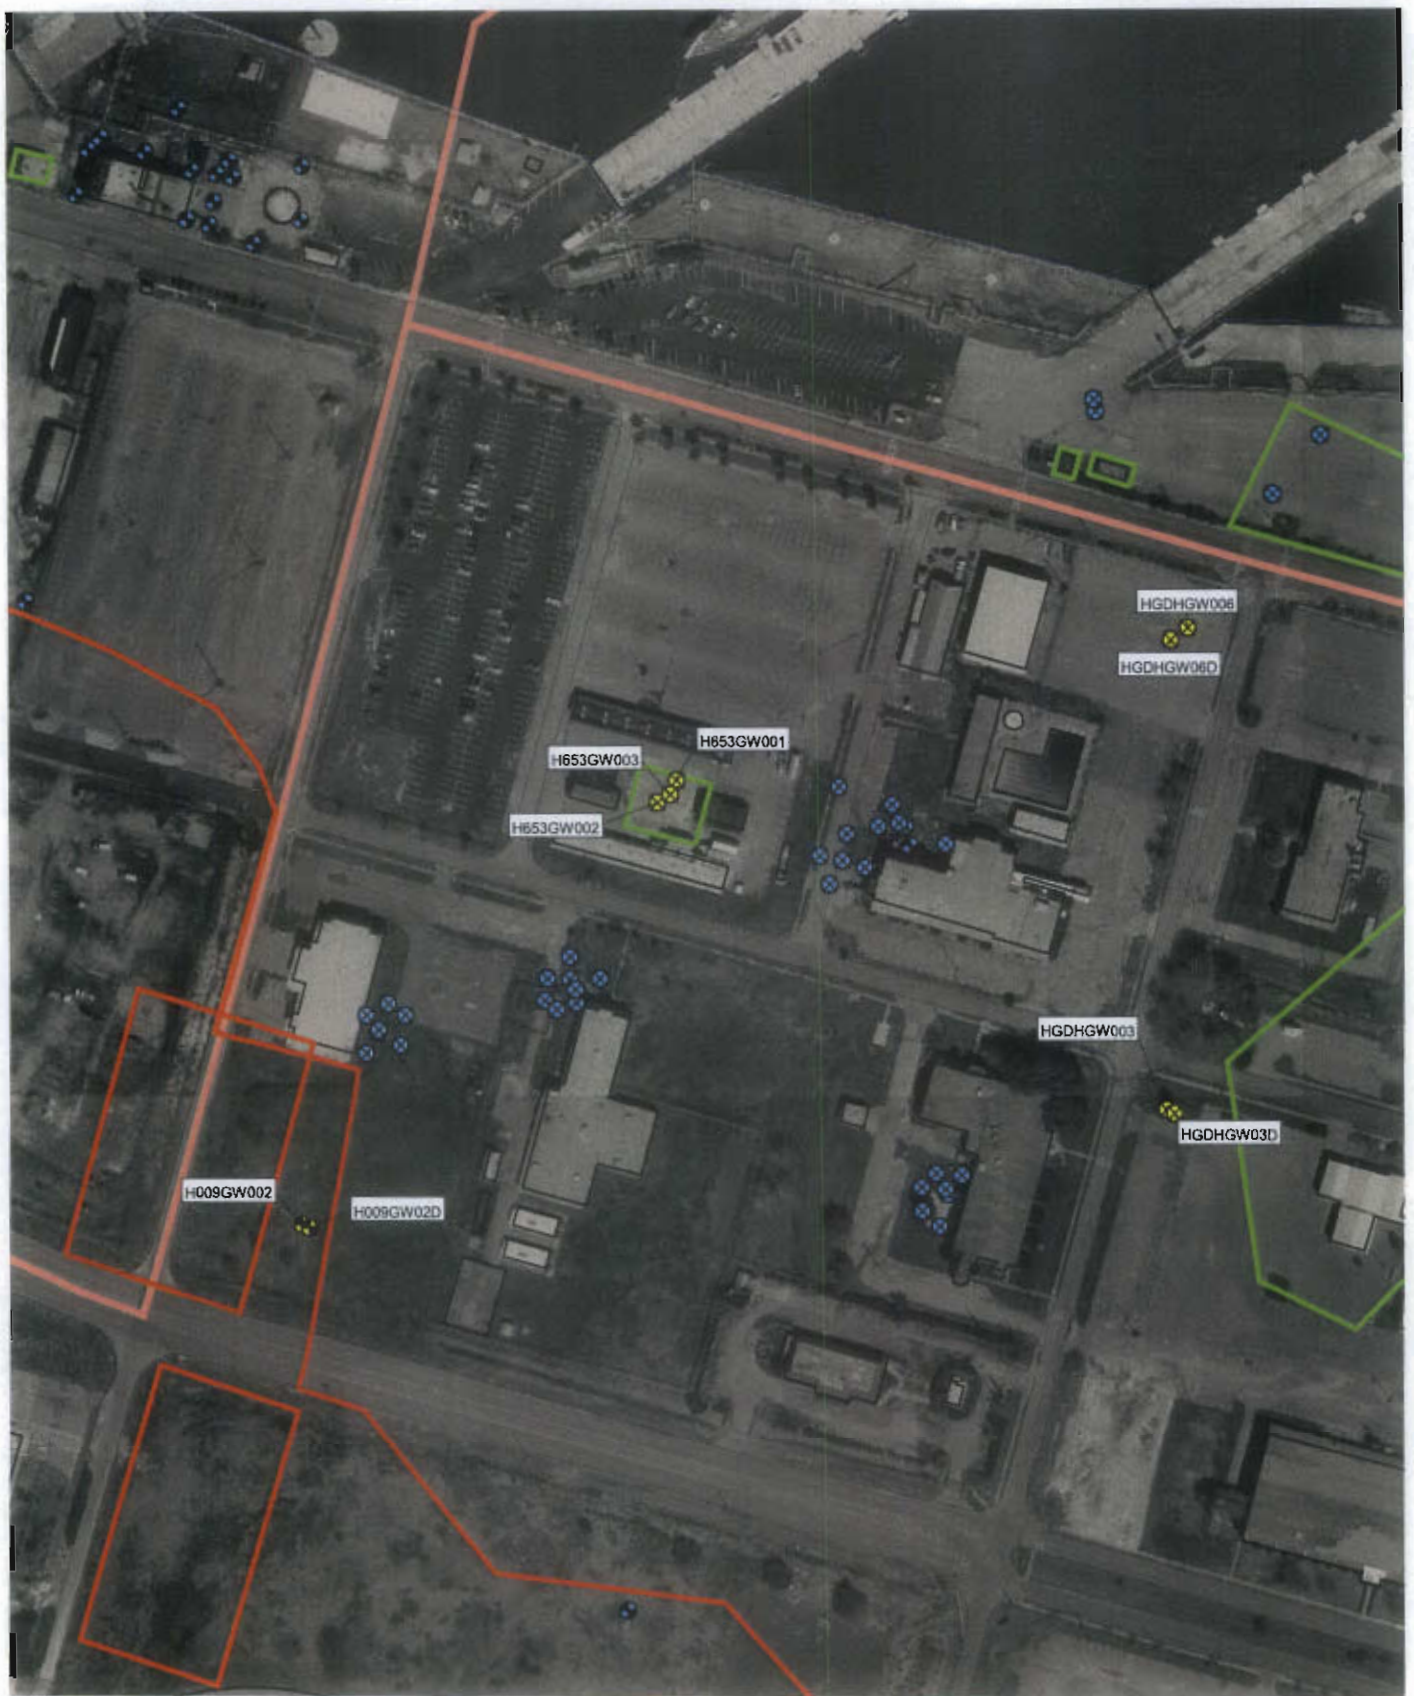
**FIGURE 3-2**  
RCRA-related Groundwater Wells Analyzed for VOCs in the Vicinity of AOC 726  
AOC 726, Zone H, Charleston Naval Complex

⊗ Abandoned  
● Active

13   **Figure 3-2** shows the locations of monitoring wells installed as part of the RFI in the vicinity  
14   of AOC 726. Only those monitoring wells that are labeled in **Figure 3-2** were installed as  
15   part of the RFI. These wells include monitoring wells installed to investigate AOC 653 as  
16   well as several grid wells installed in Zone H to assess the background groundwater quality.  
17   **Table 3-1** shows the results of detections of VOCs from those samples. Several detections of  
18   acetone, a common laboratory contaminant, were noted. One detection of trichloroethene  
19   (TCE) above its drinking water MCL of 5  $\mu\text{g/L}$  was noted in well HGDHGW003.
